**Capital Efficiency Plan™
Aquarion Water Company
Hingham/Hull Water System**

March 2011

Subject: Capital Efficiency Plan™
T&H Project No. 2061

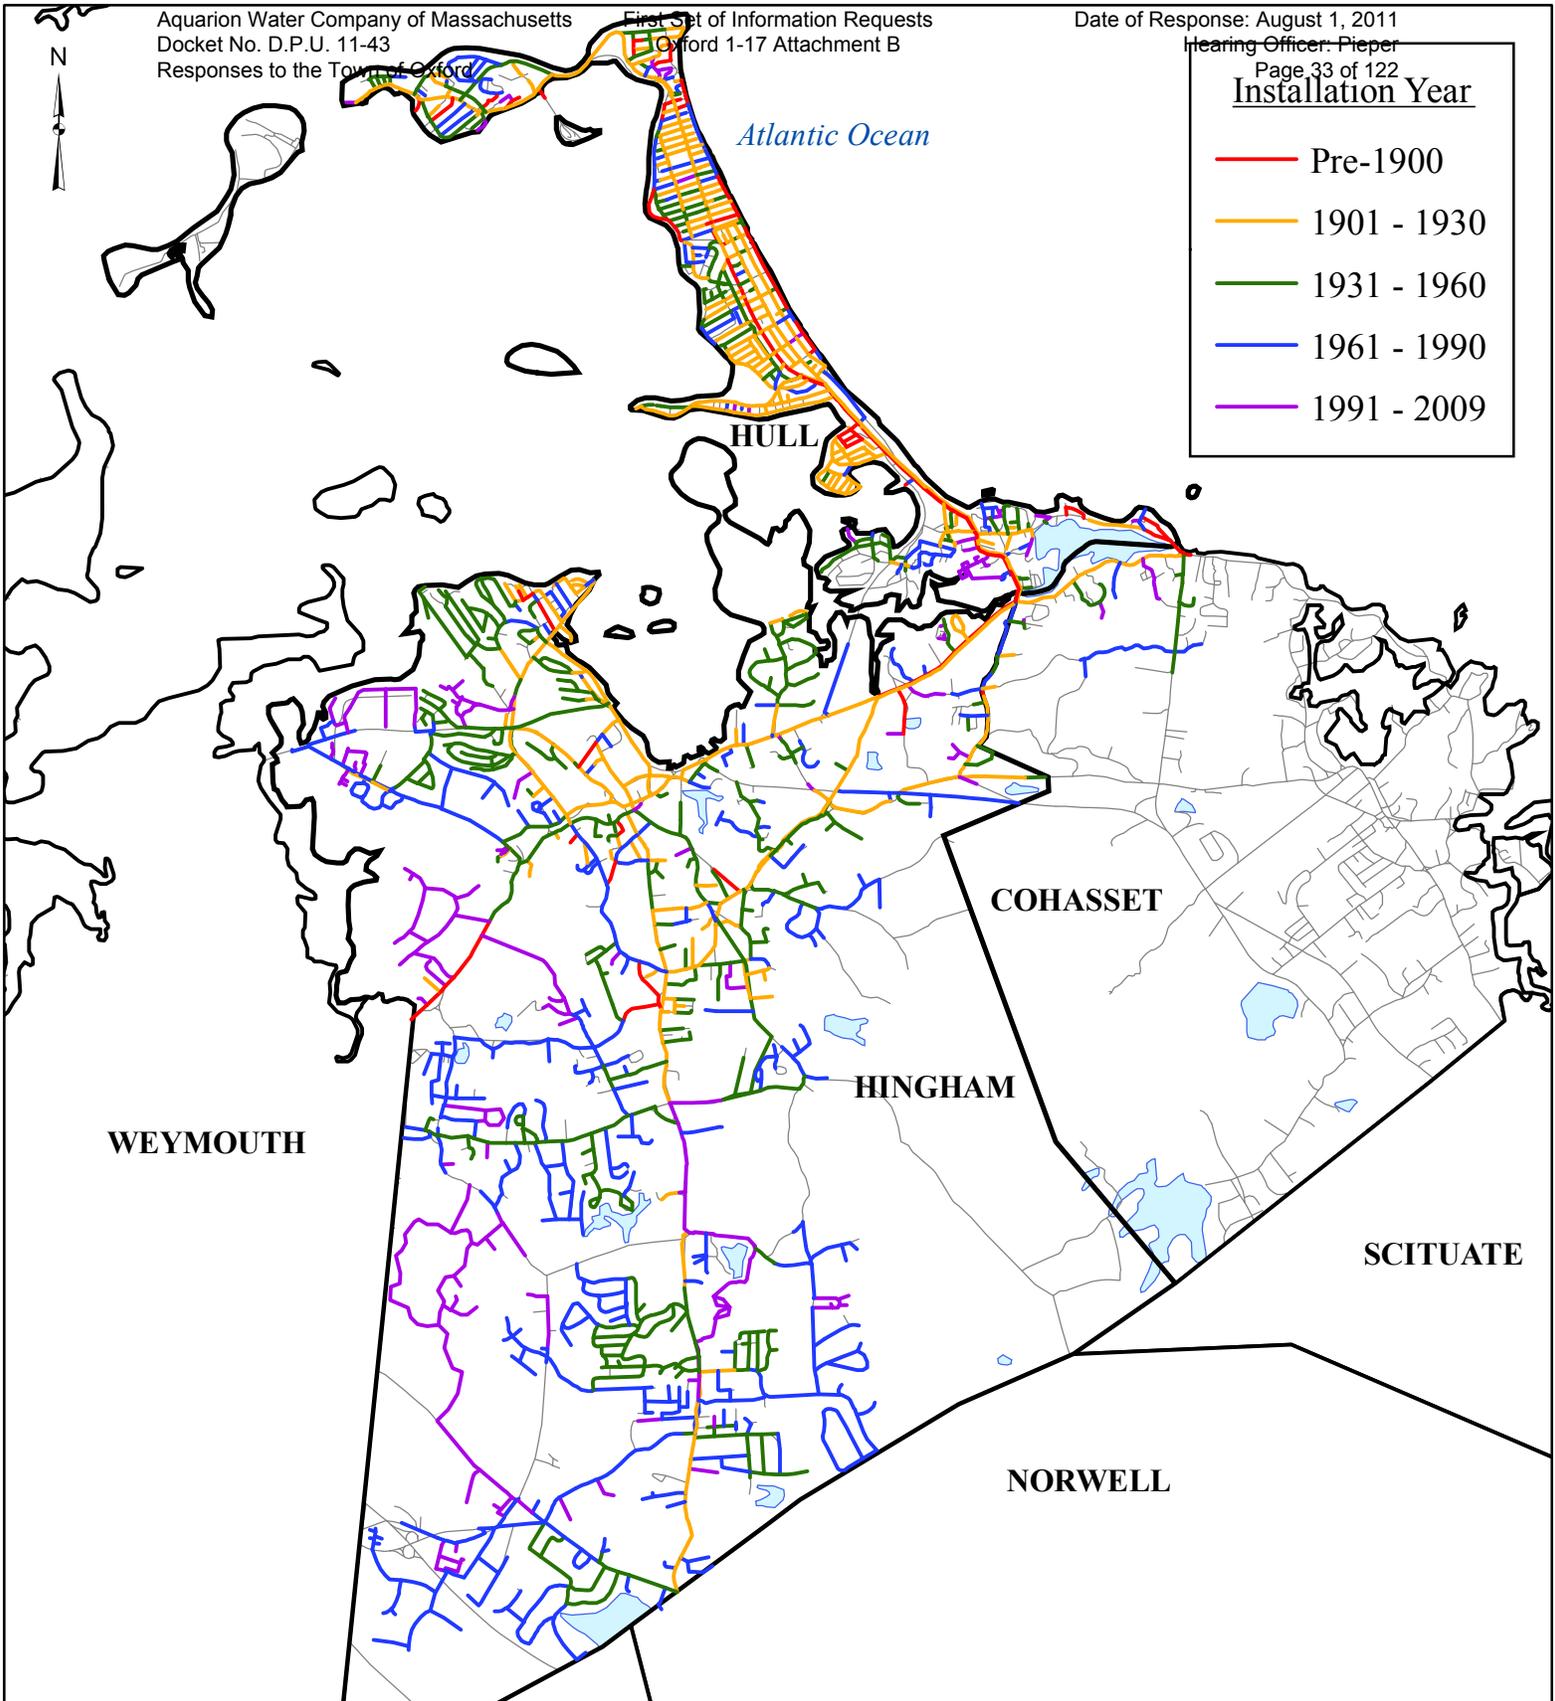
Water Main Installation Years

Installation Year

- Pre-1900
- 1901 - 1930
- 1931 - 1960
- 1961 - 1990
- 1991 - 2009
